NASA Technical Paper 1274

**Erosion/Corrosion of Turbine
Airfoil Materials in the High-
Velocity Effluent of a Pressurized
Fluidized Coal Combustor**

**Glenn R. Zellars, Anne P. Rowe,
and Carl E. Lowell**
*Lewis Research Center
Cleveland, Ohio*

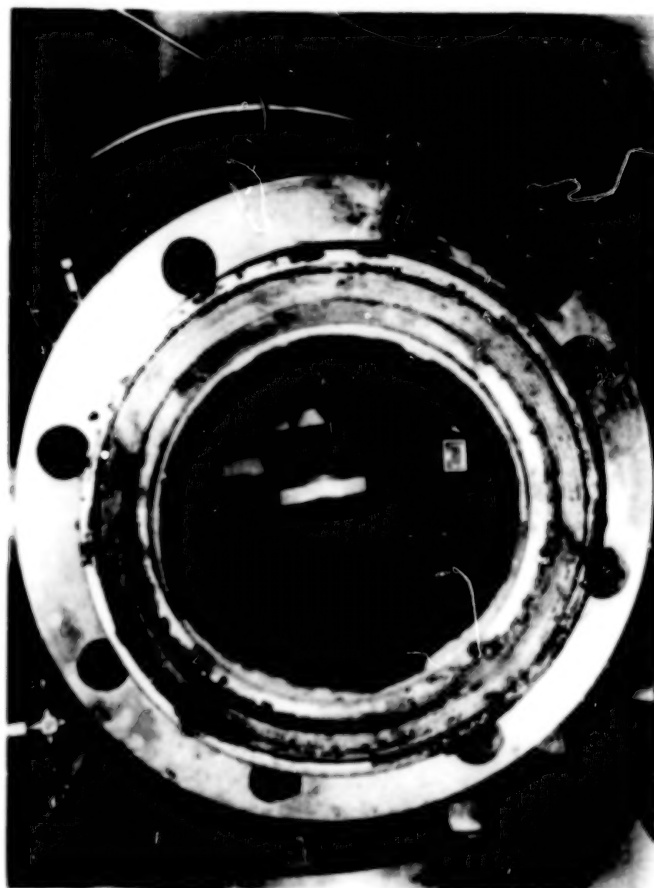
The carrousel wedge test (CWT) unit is mounted on top of the combustor as shown in figure 3. The test unit housing is a stainless-steel 15-centimeter- (6-in.) inside-diameter tee section with three mating flanges. The bottom flange of the CWT mates with the combustor exit flange and supports a straight nozzle fabricated from Haynes alloy 25 which accelerates the combustion gases from the combustor into the erosion/corrosion test unit. The top flange of the CWT mates with the hot gas exhaust system. The third flange of the CWT mates with a flange that supports a thermocouple well for gas temperature measurement and a cold finger projection for gas condensibles. Within the test unit housing the specimen holder is fixed to an external shaft that is rotated by an electric motor through a pressure seal. The specimen holder, which accommodates eight specimens, positions the specimens directly over the nozzle 2 centimeters (0.8 in.) above the nozzle exit. In figure 4 the test specimens can be seen in the holder after a test run. The photograph is taken from the top flange; the nozzle is hidden by the specimens. The thermocouple well is seen protruding through a ceramic plug at the bottom of the photograph, but the cold finger had been removed from the unit.

Figure 4. - Carrousel wedge test unit after test.

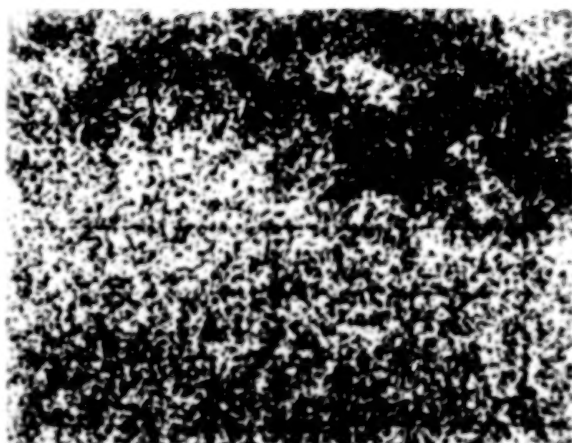
Figure 20. - Microprobe confirmation of sulfidation on IN-100 exposed at 150 meters per second and 800° C for 91 hours.
